## **MITIGATED DETERMINATION OF NONSIGNFICANCE (DNS)**

Project Name:	Calavista Planned Residential Development & Preliminary Plat
Site Location:	19700 & 19840 Caldart Avenue NE, Poulsbo WA 98370
File No.:	P-05-08-19-01
Description of Proposal:	Develop 9.05 acres into 43 single family lot Planned Residential Development (PRD) and Preliminary Plat (PP). Project area is two existing properties with one home on each property. One home will be retained. Improvements include roads with parallel parking, open spaces with recreational amenities, and utility and stormwater facilities. Access is from Caldart Avenue and Halden Glen Court. Improvements along Caldart Avenue are proposed.
Applicant:	Caldart Poulsbo, LLC; c/o Barry Margolese; 105 S. Main St., Ste. 230; Seattle, WA 98104
Tax Parcel:	132601-3-065-2006 & 132601-3-003-2001
Lead Agency:	City of Poulsbo

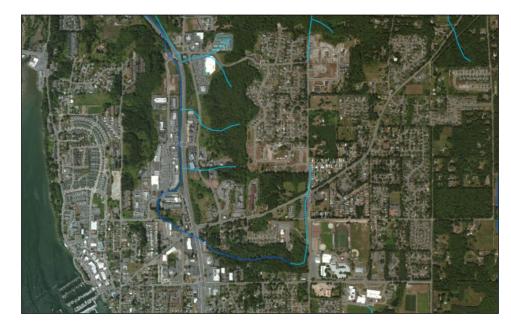
# Figure 1. South Fork Dogfish Creek Location

This technical memorandum documents the downstream assessment of the South Fork of Dogfish Creek that Soundview Consultants LLC (SVC) conducted to determine potential impacts to the drainage associated with an offsite stormwater outfall for the Calavista PRD project. In July 2019, Soundview Consultants LLC (SVC) conducted an assessment of one-mile segment of the South Fork of Dogfish Creek from its intersection with Highway 305 to the proposed outfall location immediately south of Mosjon Circle. The South Fork of Dogfish Creek is located in the City of Poulsbo within Kitsap County, Washington (Figure 1). The drainage starts in the Southeast <sup>1</sup>/<sub>4</sub> of Section 14, Township 26 North, Range 01 East, W.M. It continues on to Section 23, Township 26 North, Range 1 East, W.M. before turning back into the Western <sup>1</sup>/<sub>2</sub> of the previous section (Section 14).

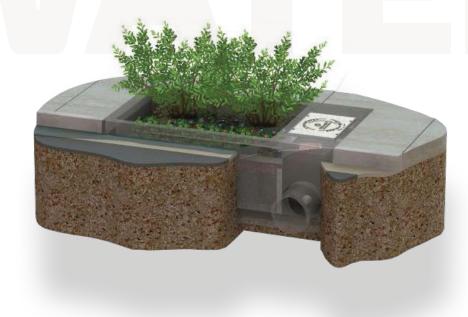
#### **BIOPOD™ SYSTEM** WITH STORMMIX<sup>™</sup> MEDIA Sustainable Green Infrastructure for Stormwater Management

BioPod systems utilize an advanced biofiltration design for filtration, sorption and biological uptake to remove Total Suspended Solids (TSS), dissolved metals, nutrients, gross solids, trash and debris as well as petroleum hydrocarbons from stormwater runoff. Environmentally friendly and aesthetically pleasing, BioPod systems are a proven, Low-Impact Development (LID) solution for stormwater treatment. BioPod systems integrate seamlessly into standard site drainage and can accommodate a wide variety of vegetation to meet green infrastructure requirements.

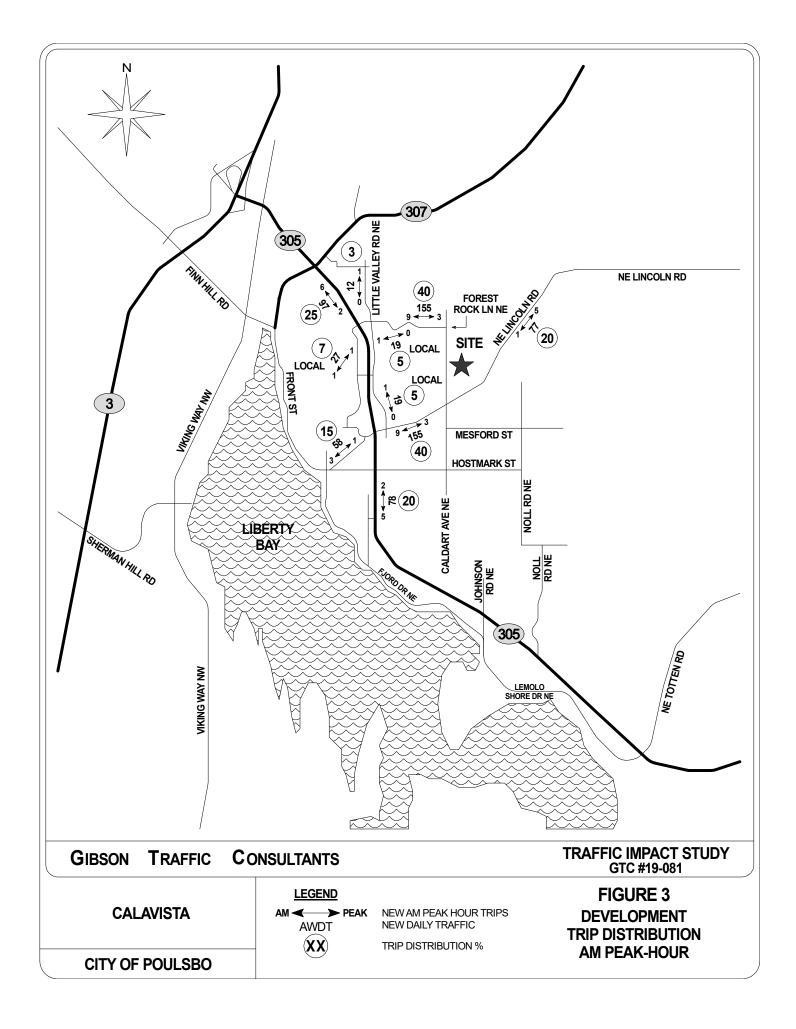
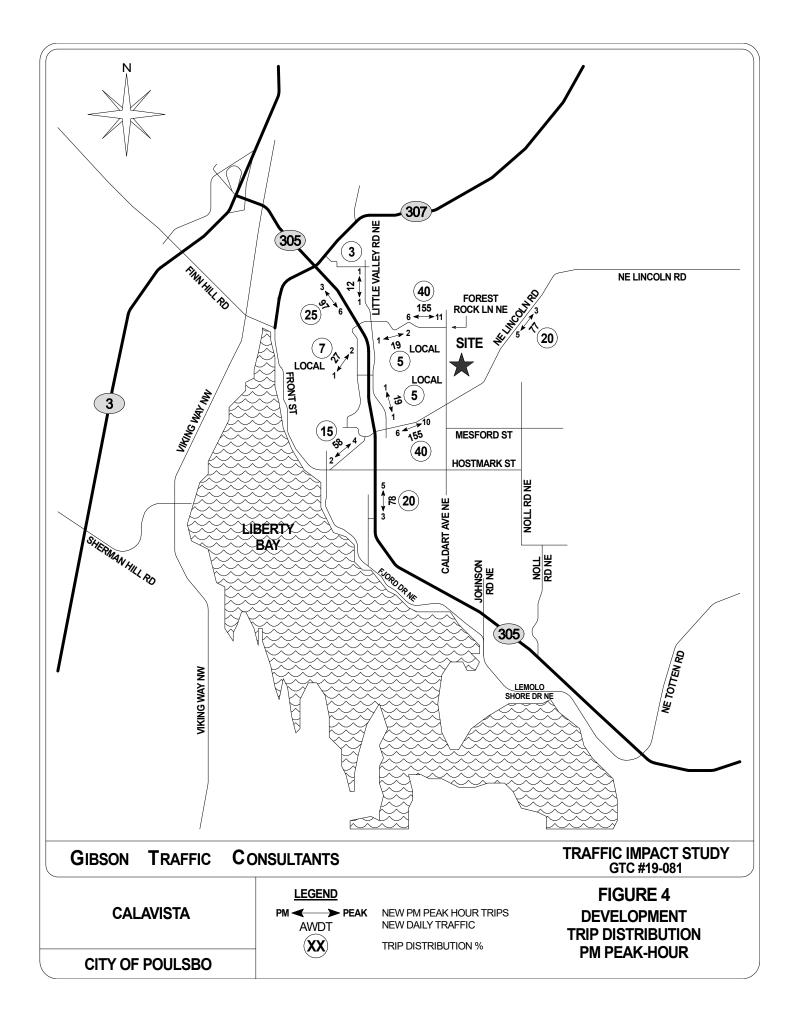
Trip distribution is based on existing counts and residential/commercial draw areas by the site. It is anticipated that 28% of the site traffic is expected to travel to and from the north, three percent along Little Valley Road and twenty-five percent on SR-305. Another 15% is expected to travel to and from the west on NE Lincoln Road. Approximately 20% of the site traffic is expected to travel to and from the east along NE Lincoln Road. An estimated 20% of the site traffic is expected to travel to travel to and from the south along SR-305. The final 17% is expected to be local trips. A detailed trip distribution for the AM and PM peak-hours is shown in Figure 3 and Figure 4 respectively.
